AN EXPERIENCE OF DESIGNING AND INSTALLING AN INFILTRATION BASIN IN CHRISTCHURCH

A.K. Brough (Pattle Delamore Partners Ltd)
R. Eastman (City Solutions, Christchurch City Council)

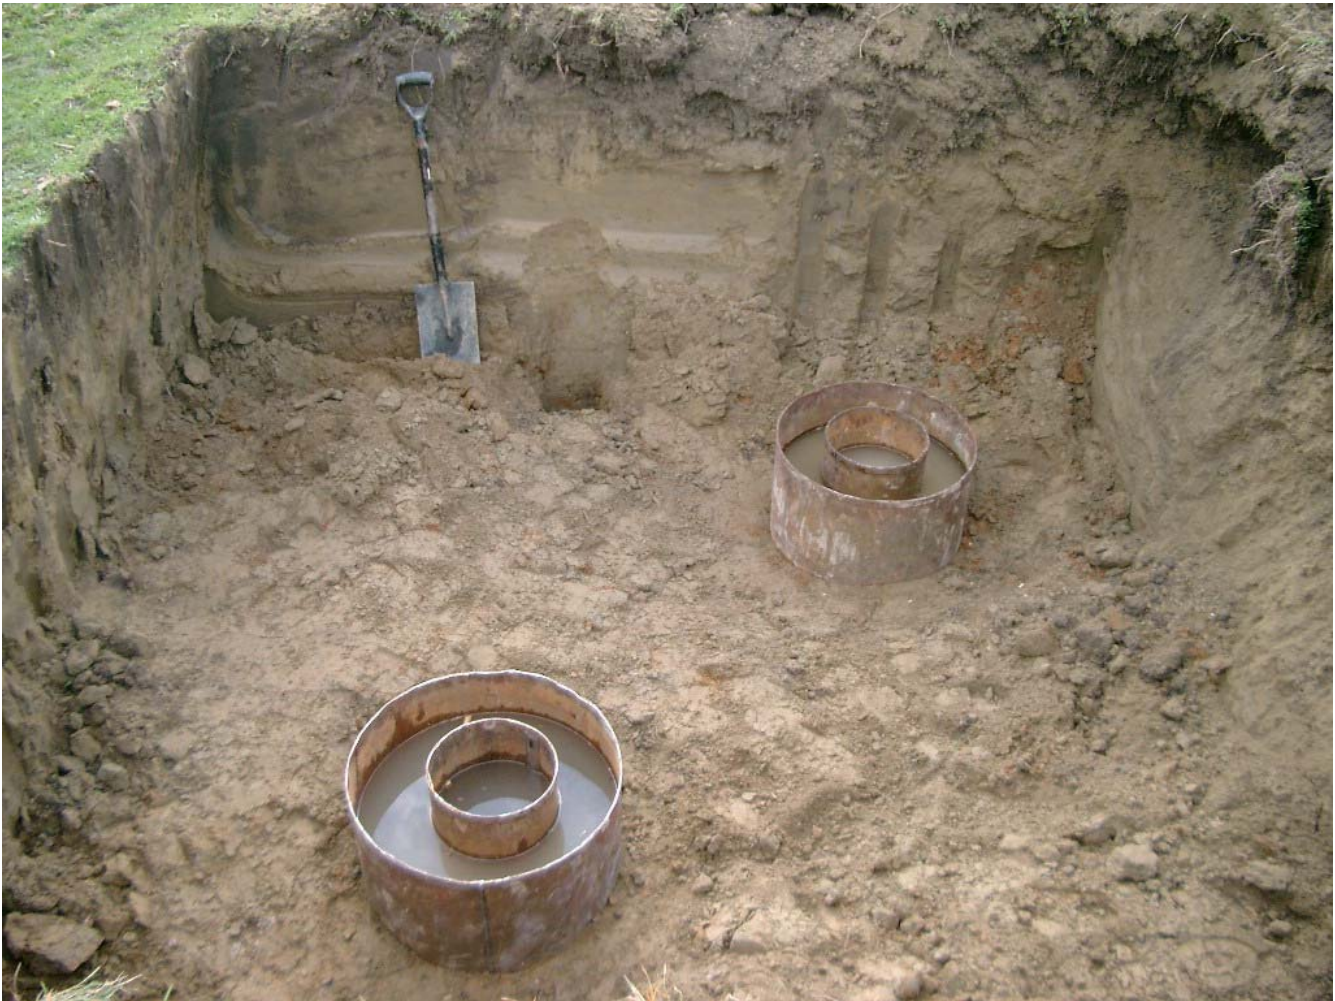
Photograph 1: Infiltration Testing of Sub-soils

The infiltration rate was tested using double ring infiltrometers. Briefly, these consist of large and small concentric rings driven into the ground to a depth of approximately 100 mm. The inner ring and outer ring are filled with water to a depth of between 100 and 200 mm (Photograph 1). The rate at which water falls within the inner ring is measured at intervals ranging from 1 minute to 1 hour, depending on the soil type, until there is an equal fall over three consecutive readings.

Two double ring infiltrometer tests were carried out in each test pit. The ultimate infiltration rates are shown in Table 2. These show low infiltration rates that require modification of the infiltration basin to allow successful operation of the basin. The design of the infiltration basin is provided in section 3.

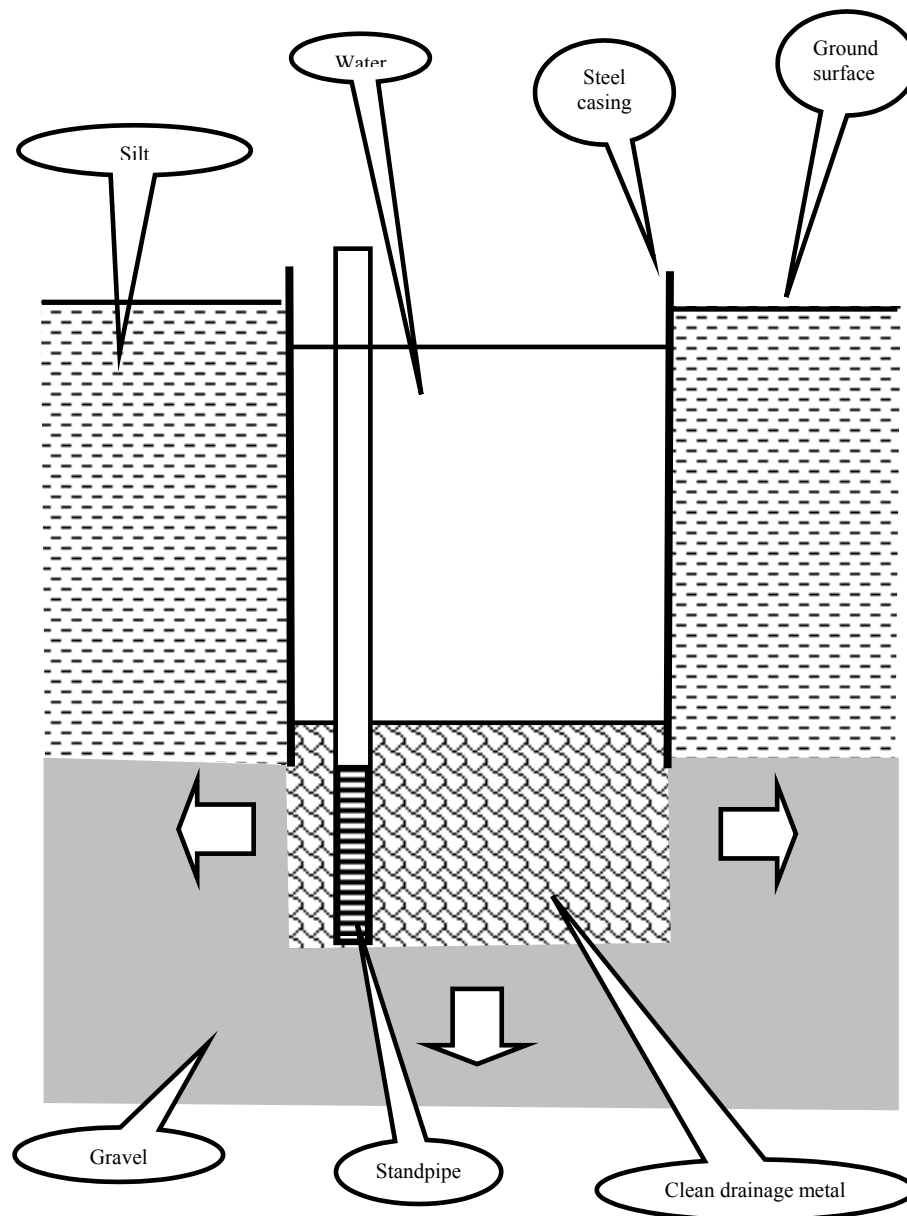
Figure 3: Schematic of Permeability Test Set-Up

1. A nominally 1.1 m diameter hole was drilled by auger through a confining layer of silt to gravel strata, and thence for approximately 0.5 m into the gravel strata, and a 1.05 m diameter steel casing emplaced (Figure 3, Photograph 2). During the drilling process some sand and silt material was allowed to descend to the base of the hole; this was largely removed by pumping prior to the testing procedure.

2. A 50 mm diameter slotted standpipe was placed within the casing, near the casing side (Figure 3, Photograph 2). This was protected within a sleeve consisting of a perforated 100 mm diameter plastic pipe. Approximately 0.6 m³ of 100 mm diameter clean drainage metal was placed at the bottom of the cased hole, around the standpipe assembly. The casing was retracted by 0.4 m. The drainage metal effectively supports the exposed gravel strata at the bottom of the hole when the casing is retracted (in effect acting as a screen). The standpipe allowed precise measurement of water levels within the cased bore.

3. The annulus around the outside of the casing was filled with pea gravel up to a depth above the natural gravel strata and then backfilled to ground level with low permeability silt. This allowed water levels within the casing to be raised to greater than ground level.

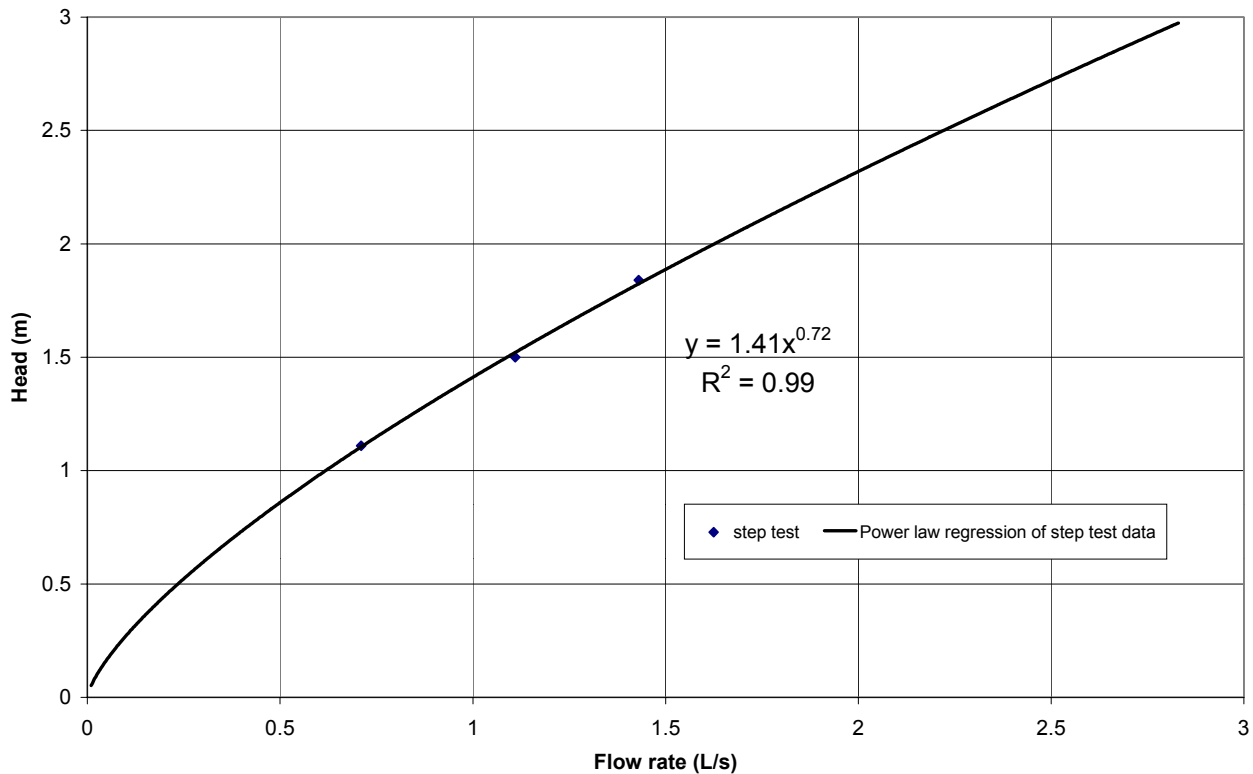
Figure 4: Step Infiltration Test Data

The results of the three constant discharge tests were analysed (Figure 4). The constant discharge tests were modelled using a simple Darcian flow technique whereby the relationship between water pressure and surface area of infiltration relate to the hydraulic conductivity of the gravel strata. The three tests furnished three separate measurements of hydraulic conductivity.

The three constant rate discharge tests were analysed by using a modified Darcy Law relationship that accounted for both radial and vertical flow out of the cased hole. The tests gave a mean hydraulic conductivity of the gravel strata at the bottom of the cased hole of 5.7×10^{-4} m/s. The values for hydraulic conductivity are close to the lower part of the range expected for gravel strata of 10^{-3} to 10^{-1} m/s as quoted in Freeze and Cherry (1979).

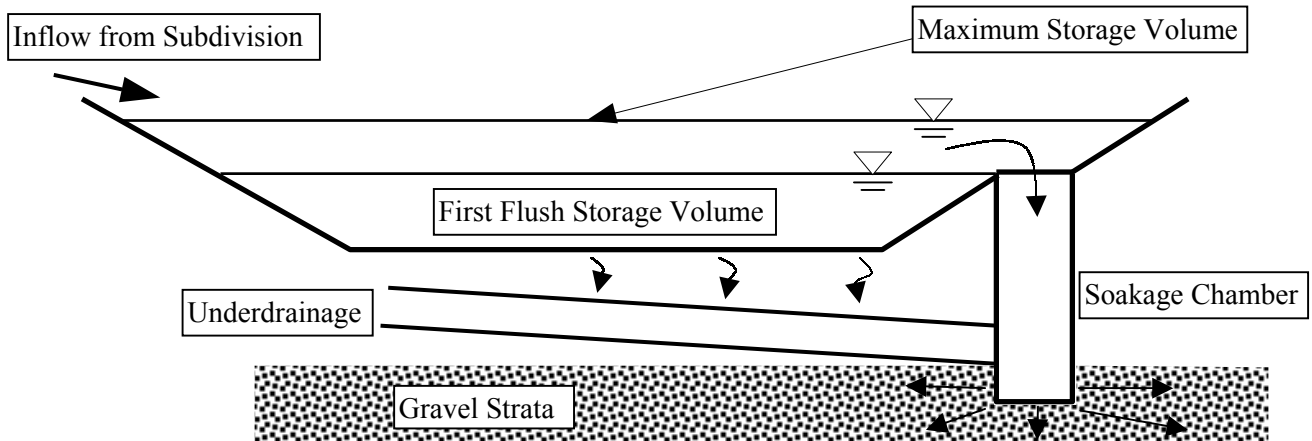
Figure 5: Conceptual Layout of Infiltration Basin For Modelling Purposes

In situations where the infiltration rate of the subsurface materials is below 20 mm/hr then the consent permits the use of an under drainage system. This was utilised in this instance. The water that is collected in the underdrainage system is then discharged into the soakage chamber. This underdrainage flow needed to be included in the sizing of the soakage chamber. A conceptual layout of the infiltration basin and soakage chamber used in the modeling is shown in Figure 5.

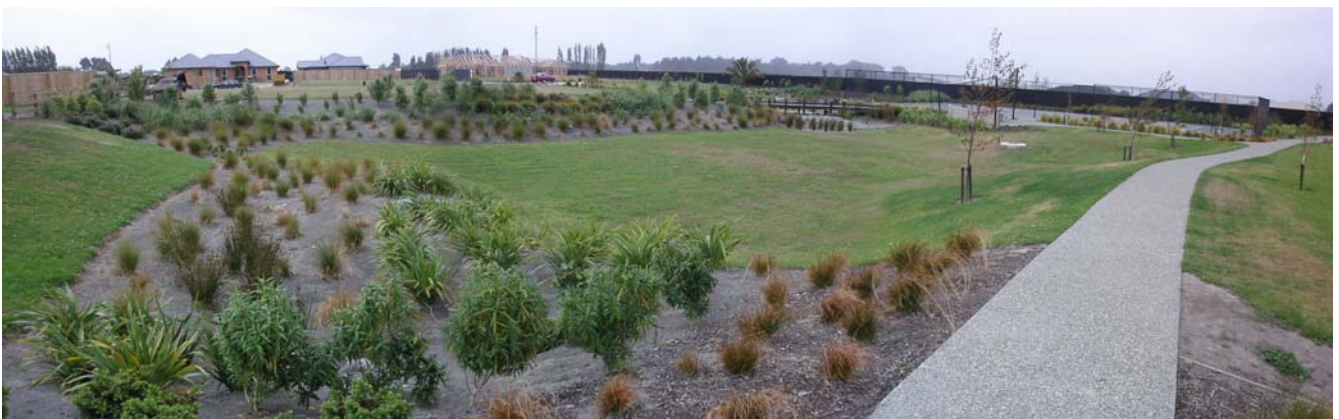
Photograph 3: Infiltration Basin

Photograph 3 shows the as-built infiltration basin looking to the north-east. Note that the tennis court will be inundated in storms of greater than 10 year return period.

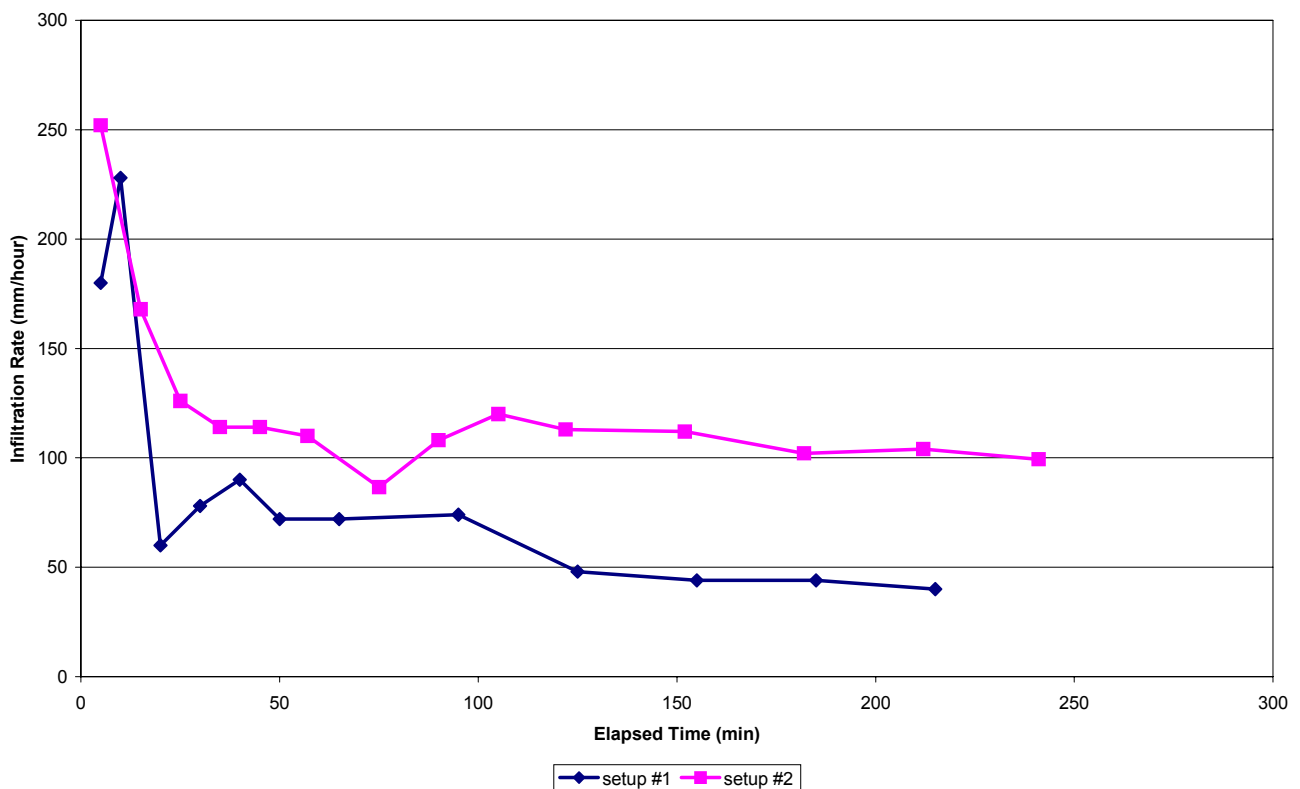
Figure 7: Infiltration Test Results

Two double ring infiltrometer tests were carried out on the infiltration basin in November 2004, approximately 3 months after the basin was completed and became operational. These are shown in Figure 7. The results give infiltration rates of 40 and 99 mm/hr. It is possible that these are not the ultimate saturated infiltration rates, as shown by the slightly declining slope at the end of the graphs, despite having run the tests for between 3.5 and 4 hours. One test indicates compliance with the conditions of the resource consent, but the other does not. The different results are probably due to two reasons,

- The difficulty of obtaining a good seal between the infiltrometers and the surrounding soil potentially resulting in short circuiting of water and measurement of higher infiltration rates,
- The soil in the basin was created by mixing top soil with sand meaning that there is the potential for some areas to have more sand, and some areas to have less sand which would result in variable infiltration rates.

The results that were obtained indicated, that while these did not necessarily comply with the conditions of the resource consent, the mixing of the sand with the soil successfully created a freer draining material than using the existing top soil on the site by itself, and that the infiltration rate was at the higher end of the acceptable range allowing for some progressive clogging over time so that the base should maintain acceptable infiltration rates for an extended period. It is considered that it would be prudent to leave the surface as it is rather than trying to remediate it to get a consistent infiltration rate over the whole surface.
